LONG SECTION SAN MANUEL-KALAMAZOO

Block Caving Design

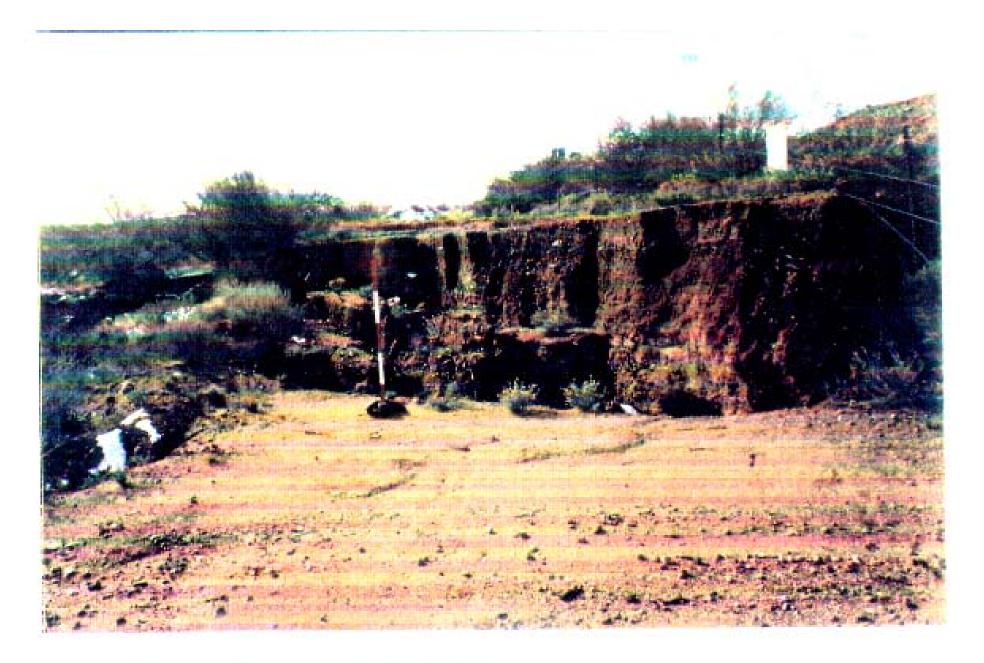
Western Escarpment, On Dirt Road

Top 1993 Bottom 1995
